Corrective and Preventative Action Report

CPAR # 000116

27/02/2017

The Western Ventilation Stack Outlet, as described in the Legacy Way Environmental Authority ERA51- EPPR02587314.

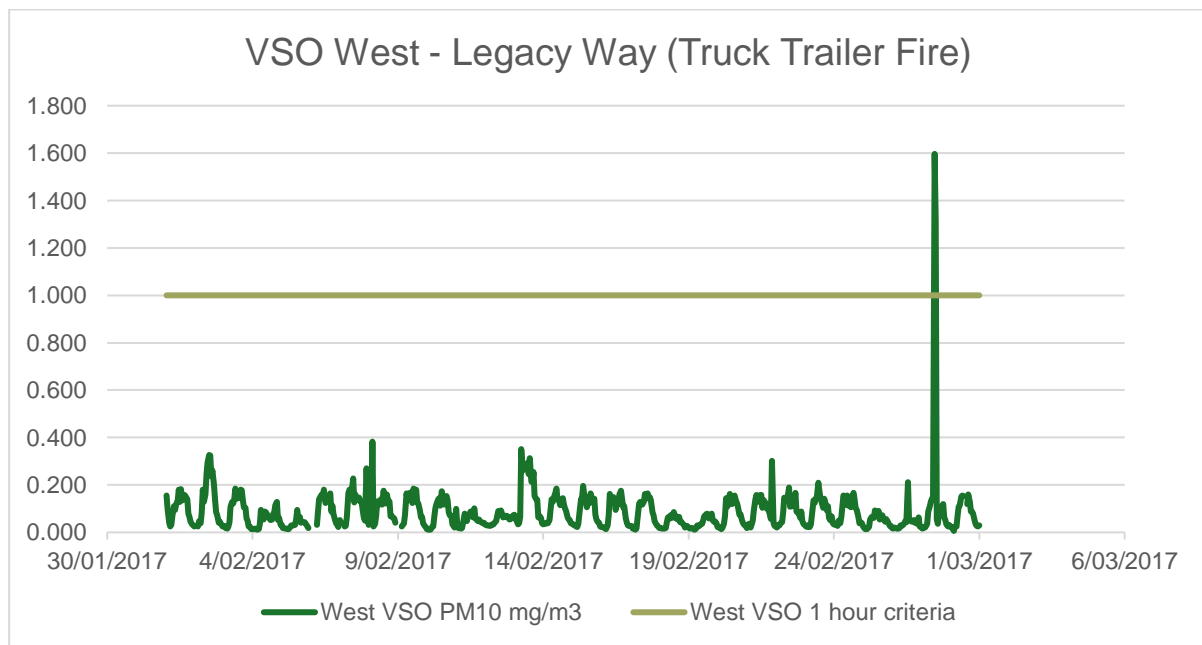
Figure 5 - VSO West Exceedance due to Truck Trailer Fire 27/2/2017

The above spike in the graph illustrates exceeding the PM10 1 hour criteria in the west ventilation stack outlet during the truck trailer fire incident. It is important to note that there was no exceedance of in-tunnel air quality, nor at the ambient air quality stations at the ends of the tunnel.

West VSO PM₁₀ – 1 hour – 1.597 mg/m³ on 27/02/17 11:00am

West VSO PM₁₀ – 1 hour – 1.312 mg/m³ on 27/02/17 12:00pm

This was a fire incident and was outside the normal operating conditions of the tunnel. Despite this, the monitoring results demonstrate that in-tunnel and ambient air quality was maintained within criteria levels specified in the Environmental Authority. The ventilation stack did exceed the 1 hour criteria for PM10, however, this has not resulted in exceedance of ambient or in-tunnel air quality.

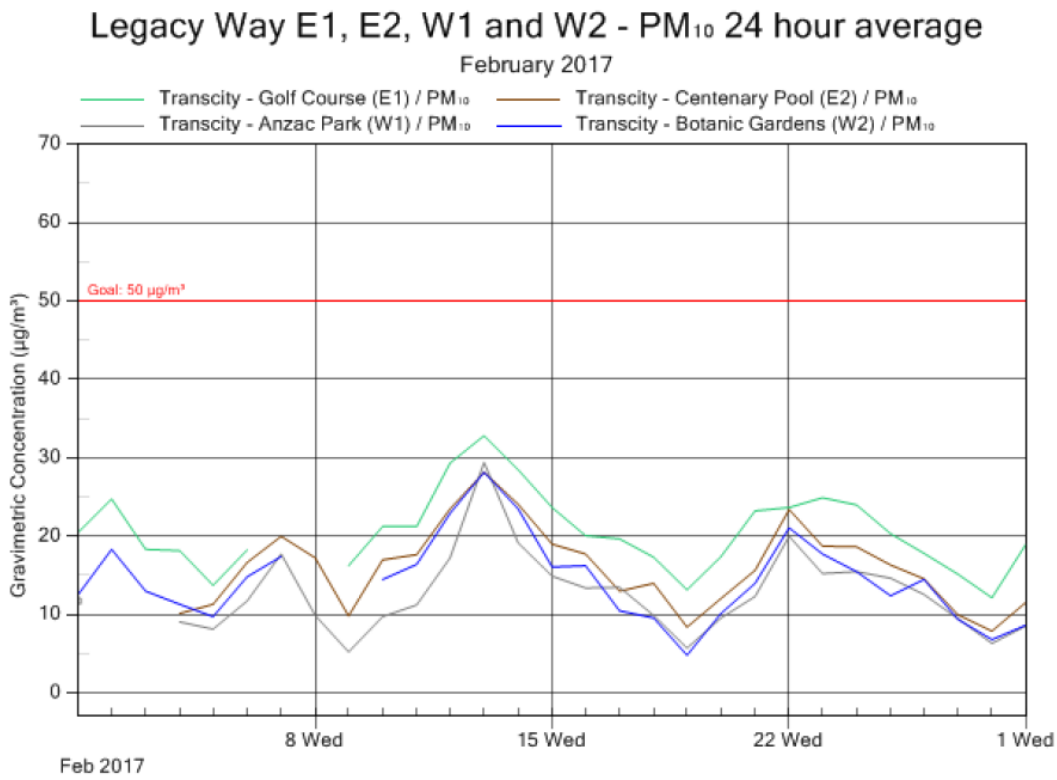
Please note that the ambient PM10 and PM2.5 air quality all remained within the 24 hour criteria as per the Environmental Authority (no exceedance of ambient air quality).

Figure 6 - Legacy Way (E1, E2, W1 and W2) PM10 graph for Feb 2017

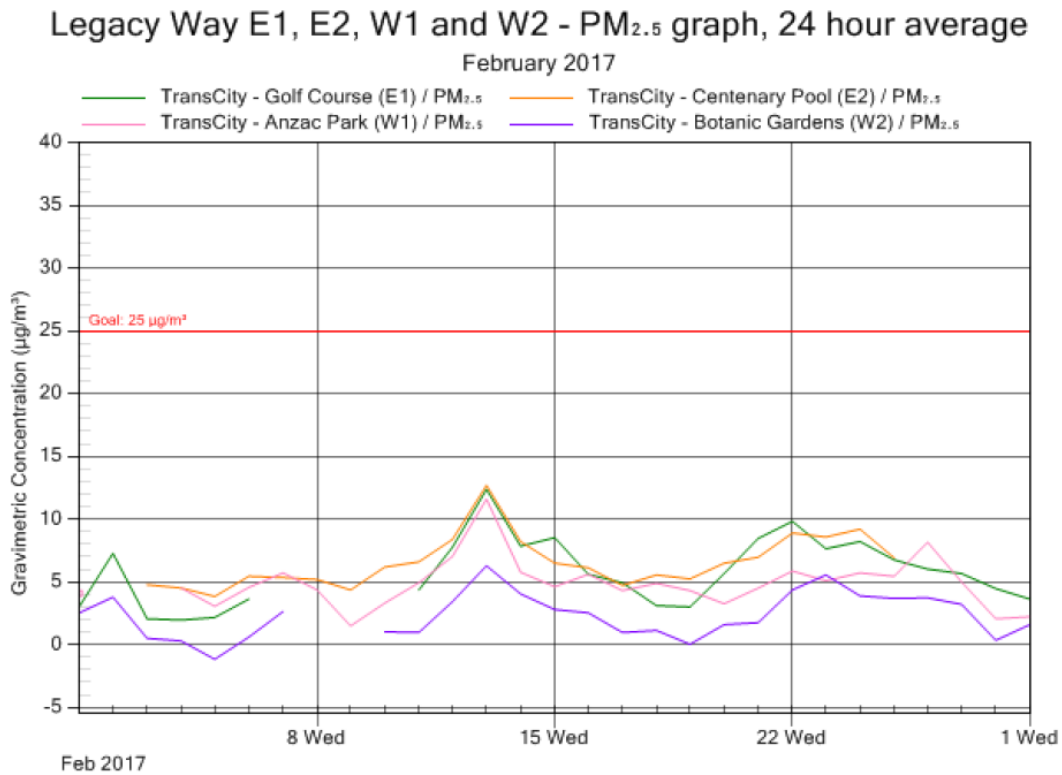
Figure 7 - Legacy Way (E1, E2, W1 and W2) PM2.5 graph for Feb 2017
