RE: Report on Ventilation Outlet Above-Limit Reading M4 East Motorway – 6 June 2020

Ventilation Outlet Monitoring Reporting

Report on Ventilation Outlet above-limit reading WestConnex M4 East To be submitted to DPE within 20 days of the Report of Above-Limit Reading					
Details of the exceedance Attach relevant Notification of Above-limit Reading	<p>This report has been prepared to address the requirements under MCoA E16:</p> <p>“Should the results of monitoring show that any of the ventilation outlet limits specified in condition E14 have been exceeded, the proponent must immediately notify the Secretary, EPA and NSW Health. The notification must be followed up with a detailed report within 20 working days, which must be prepared by the proponent, reviewed by a suitably qualified and experienced independent specialist(s), and submitted to the Secretary, on the cause and major contributor of the exceedance and the options available to prevent recurrence.”</p> <p>The VOC parameter at Paramatta Ventilation Facility (PRVF), eastern ventilation facility, reported above-limit readings on 6th June 2020. The reading was as follows:</p> <ul style="list-style-type: none"> - VOC –One hour

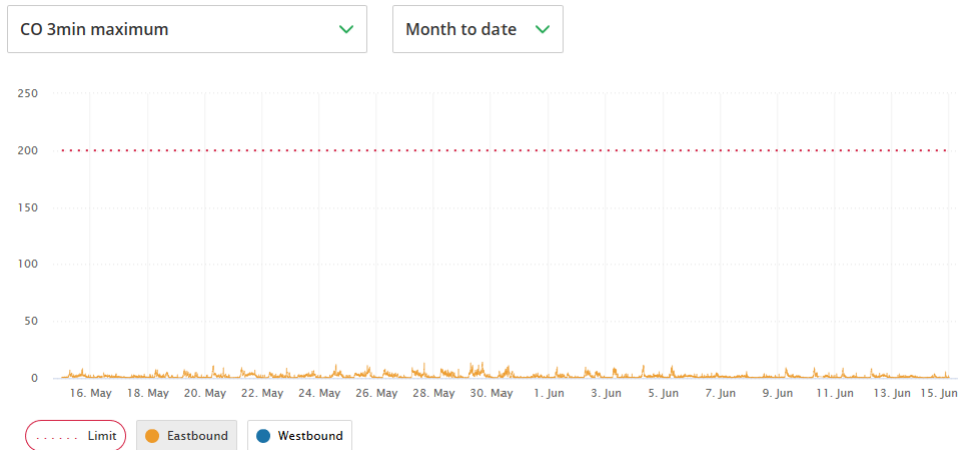
2.1.1 CO (ppm) – 3 min maximum

The following diagrams were captured from the official website for Air Monitoring on M4E. In tunnel data from 16/5/2020 to 15/6/2020 are displayed. Readings for Carbon monoxide (CO), Nitrogen dioxide (NO₂) and visibility, eastbound (yellow), showed no limit exceedances across this date range. Similarly, no in tunnel exceedances for air quality parameters were recorded in tunnel westbound.

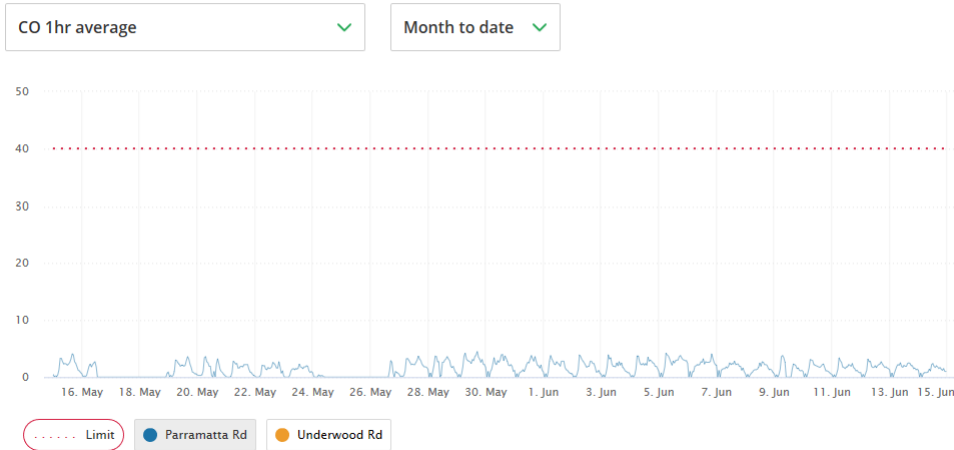
2.2.1 CO 1 hr average

The following diagrams were captured from the official website for Air Monitoring on M4E ventilation outlet from 16/5/2020 to 15/6/202. The reported VOC exceedance is shown in 2.2.5, all other air quality parameters measured during the same time- period were below limit. These parameters include Carbon Monoxide, Nitrogen Dioxide, Nitrogen Oxides and Solid Particles.

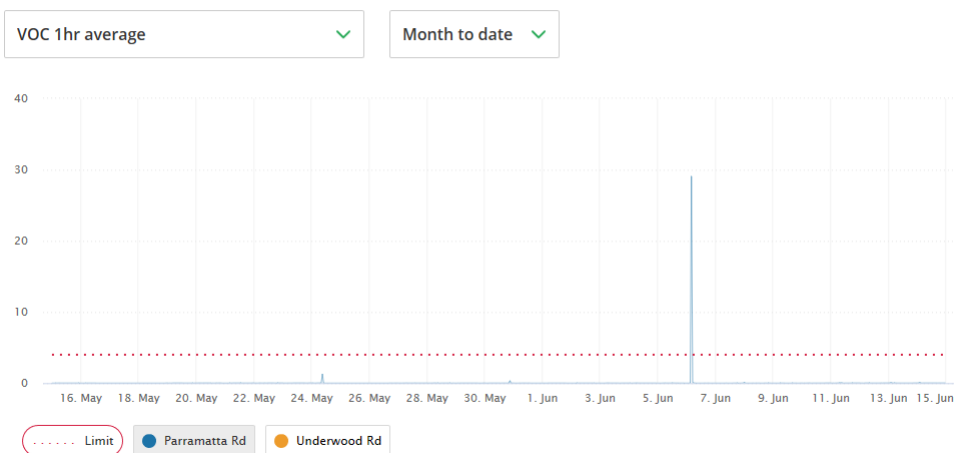
2.2.5 VOC 1 hr average

outlets is 4.0mg/m³. The hourly average above-limit-reading recorded on 6 June 2020 was 29.1 mg/m³ during the period 0400hrs – 0500hrs which is outside of standard peak hour periods.

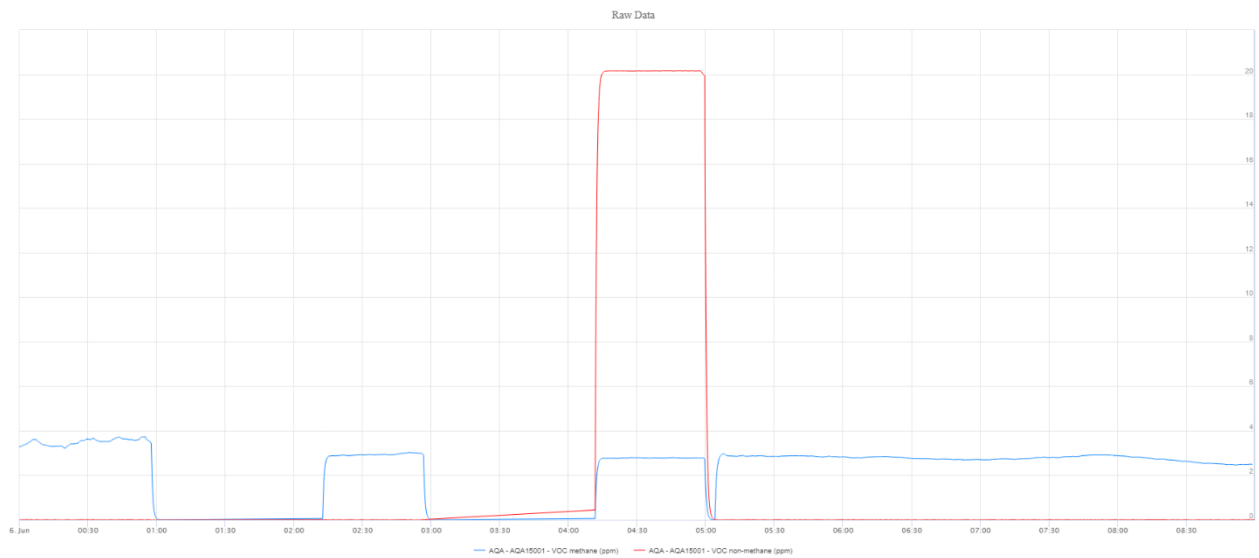
3.1.1 Raw data from OCMS from AQA15001 VOC (ppm) 6.6.2020

The following graph (3.2.1) below displays raw data captured from the OMCS AQA15001 two hours before, during and two hours after the exceedance event on 6th June 2020. The blue line represents VOC methane and red line represents VOC non-methane and indicates that the above-limit exceedance was related to non-methane gas readings.

Investigation of OMCS data from AQA15001 suggest that the above-limit VOC exceedance occurred at the exact time as a daily automatic calibration sequence. From examining calibration time points and the raw data generated from AQA15001 on the 6th June 2020 (Section 3), the analyser appears to be functioning correctly at all calibration time points examined, except for the time point when the above-limit exceedance occurred. It is suggestive the relay responsible for triggering a calibration sequence has temporarily malfunctioned.

System engineers are continually working on the back end of the OMCS to recognise when a calibration sequence is active and flag the data as invalid and hence prevent uploading invalid data to the Linkt website. Since the completion of rectification works by Ecotech and system engineers, this investigation suggests that air quality analyser AQA15001 overall undergoes routine calibration without uploading invalid data to the linkt website and the one-off VOC above-limit at calibration time 4:11 am on 6th June 2020 was atypical. At this stage, continued monitoring of calibration data for drifting or fault issues and necessary adjustments by specialist technicians in compliance with Australian Standard methods is recommended.
