Ventilation Outlet Monitoring Reporting

Report on Ventilation Outlet above-limit reading WestConnex M4 East To be submitted to DPE within 20 days of the Report of Above-Limit Reading					
Details of the exceedance Attach relevant Notification of Above-limit Reading	<p>This report has been prepared to address the requirements under MCoA E16:</p> <p>“Should the results of monitoring show that any of the ventilation outlet limits specified in condition E14 have been exceeded, the proponent must immediately notify the Secretary, EPA and NSW Health. The notification must be followed up with a detailed report within 20 working days, which must be prepared by the proponent, reviewed by a suitably qualified and experienced independent specialist(s), and submitted to the Secretary, on the cause and major contributor of the exceedance and the options available to prevent recurrence.”</p> <p>The VOC parameter at Underwood Road Ventilation Facility (URVF), western ventilation facility, reported above-limit readings on 6th February 2020. The reading was as follows:</p> <ul style="list-style-type: none"> - VOC – hourly average of 12.23 mg/m³ at 1400 - 1700hr <p>The immediate notification of ven

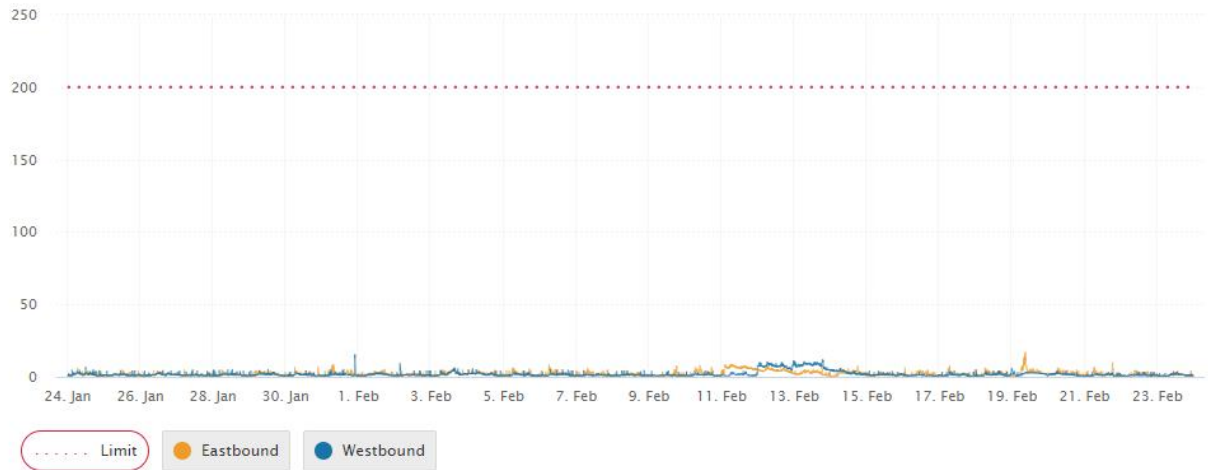
2.1 CO (ppm) – 3 min maximum

The following diagrams were captured from the official website for Air Monitoring on M4E. In tunnel data from 24th Jan to 23rd February 2020 are displayed. Readings for Carbon monoxide (CO), Nitrogen dioxide (NO₂) and visibility, westbound (blue), showed no limit exceedances on 6th Feb 2020.

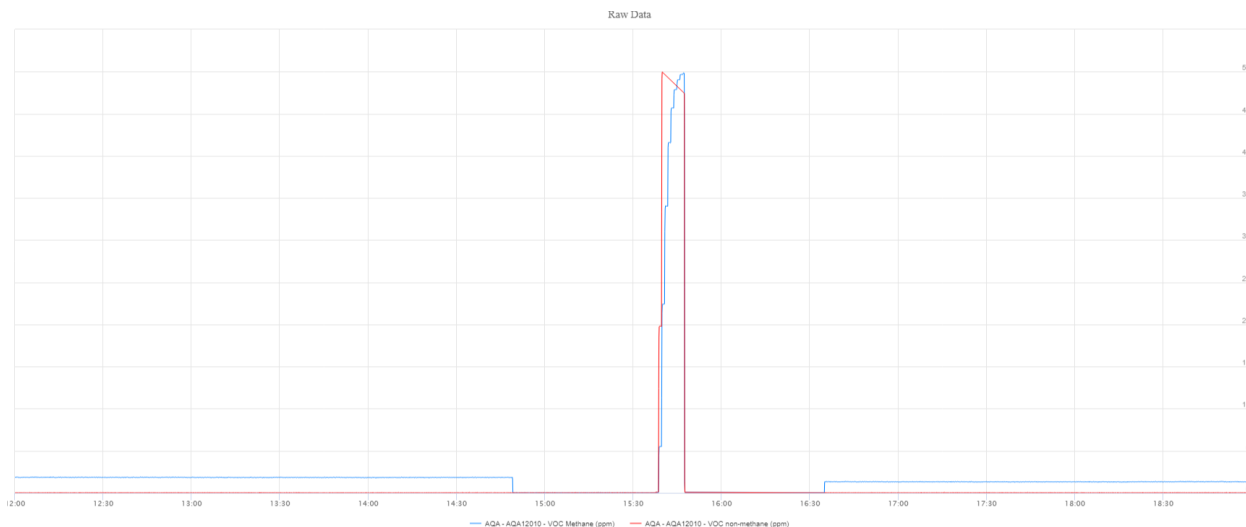
3.1 AQA12010 VOC (ppm) 6.2.2020 1200 hr – 1900hr

The Air Quality Analyser (AQA) used in URVF is AQA12010. The data captured from the OMCS AQA12010 two hours before, during and two hours after the exceedance event on 6th February 2020 (1200hr to 1900hrs) are displayed below.

The above-limit VOC reading at Underwood Road Road Ventilation Facility of 12.23 mg/m³ on the 6th of February 2020 can be attributed to maintenance work on the analyser resulting in the uploading of invalid data to the operational management control system (OMCS). At the time, the upload of invalid data was unpreventable during repair works by Ecotech maintenance engineers as all cables cannot be removed from between the analyser and the logger.

In section 4.2 – Ecotech Maintenance Report, the period of exceedance corresponds with the maintenance log. The Ecotech maintenance technician was on site at URVF from 0800 – 1730 whilst the above-limit VOC reading was between 1400-1700. This further contributes to the fact that the reading was a result of planned maintenance.

Current defects present within URVF are resulting in continual instrument drift of the VOC analyser and requires frequent attention from Ecotech maintenance technicians. Issues with the zero span/daily check are the primary driver. Compounding the issue, maintenance data has previously been allowed to upload directly onto the OMCS and hence the Linkt website. Rolling out of maintenance mode across all air quality assets is the overarching resolution to stop maintenance related exceedances.

The main recommendation is to ensure the reliability of maintenance mode on air quality assets, this is currently being looked into by the senior systems control engineer.
