**RE: Tunnel Air Quality Management Systems Effectiveness Report  
11 February 2020**

## Tunnel Air Quality Management Systems Effectiveness Report

WestConnex M4 East

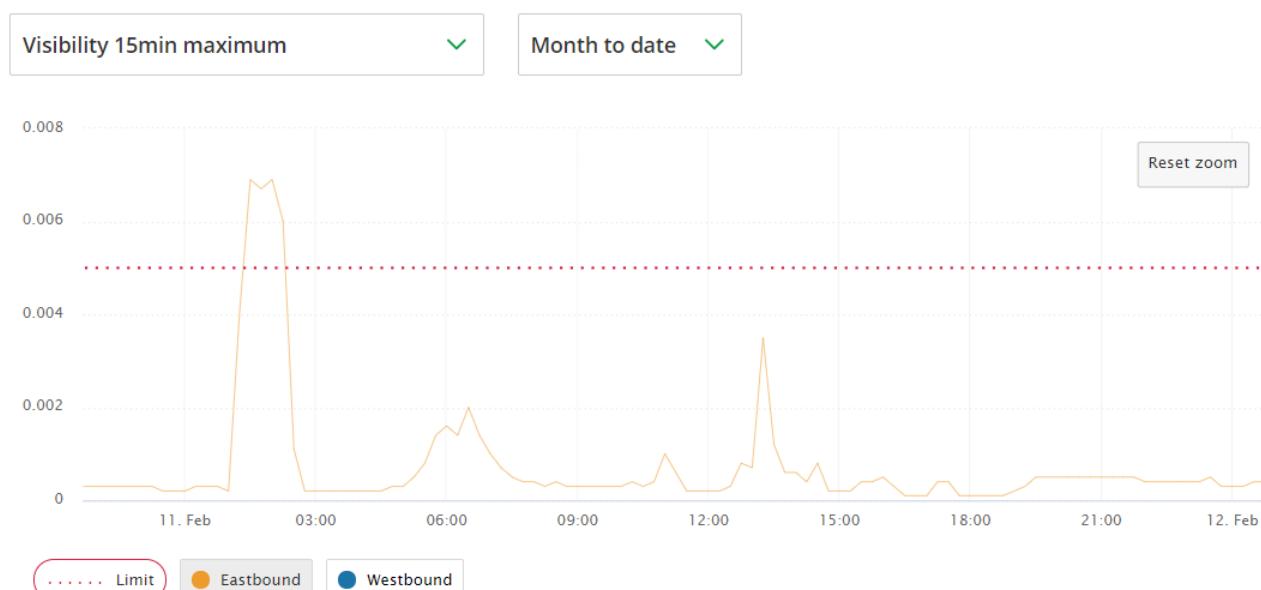
#### 2.1.1 Visibility 15 min maximum – Above-limit reading 11<sup>th</sup> February 2020

<b>Notification of In-Tunnel above-limit reading</b> WestConnex M4 East		
<p>To be notified immediately to Project Company and RMS. Project Company is to notify DPE, EPA and NSW Health within 24 hours.</p>		
Date	11 <sup>th</sup> February 2020	
Time (start and finish)	01:15 – 02:30 hrs	
Relevant location within the tunnel	Eastbound	
Relevant limit	<input type="checkbox"/> CO – Rolling 15-minute average of 87 ppm	
	<input type="checkbox"/> CO – Rolling 30-minute average of 50 ppm	
	<input type="checkbox"/> CO – Rolling 3-minute average of 200 ppm (single point)	
	<input type="checkbox"/> NO <sub>2</sub> – Rolling 15-minute average of 0.5 ppm	
	<input checked="" type="checkbox"/> Visibility – Rolling 15-minute average of 0.005 m <sup>-1</sup>	
Above-limit reading Detail the above-limit reading that was received	Eastbound: 0.0069 m <sup>-1</sup>	
Duration Detail the duration of the above-limit reading or event	1 hour 15 minutes

Nature of event Detail nature of the event that contributed to the above-limit reading	Routine maintenance was being carried out on in-tunnel AQS on the eastbound mainline, during the tunnel closure.	
Was the data valid? If unknown at this stage, please indicate.	No. Eastbound AQS were undergoing routine maintenance and calibration.	
Was there an emergency? Refer section 6.5 of this Plan. If this is unknown at this stage, please indicate.	No.	
Measures employed Detail measures employed to minimise the concentration levels		
<b>Commitment to prepare and submit a Tunnel Air Quality Management Systems Effectiveness Report</b> A Report on Above-limit Reading will be prepared following any request by the Secretary in accordance with E7 for this notification. Please note that a Report is not required in the event of an emergency.		
Person responsible for notification	Name	Peter Redwin
	Position	Head of Operations and Maintenance

Unfortunately, a full scale reading on the visibility channel was recorded on this instrument during maintenance, which subsequently was displayed on the project website. This was noticed approximately 1 hour after the incident. We understand that the issue of 'maintenance mode' data not being filtered has now been rectified by SICE in the latest patch upgrade, and this issue should not reoccur.

The root cause of the above-limit visibility reading was attributed to maintenance work on in-tunnel Air Quality Analysers on the night of February 10<sup>th</sup> to 11<sup>th</sup> 2020. All analysers were placed in maintenance mode which prevents data from being reported to the website, however, it was noticed that AQS11001 still reported data to the system when in maintenance mode. This problem has since been rectified and should no longer occur. The AQS will be checked by Ecotech during future scheduled maintenance work.

Maintenance work on sensors to rectify interferences of NO<sub>2</sub> readings caused by recent bushfire events in Sydney were scheduled for 10<sup>th</sup> February to 13<sup>th</sup> February 2020 by Ecotech. During the process, Sensor number AQS11001 was identified as having a problem in that it failed to stop reporting data when set to maintenance mode. This problem has since been rectified by SICE in recent upgrade works. Ecotech will check that the issue has been resolved during the next maintenance work (closure) period.

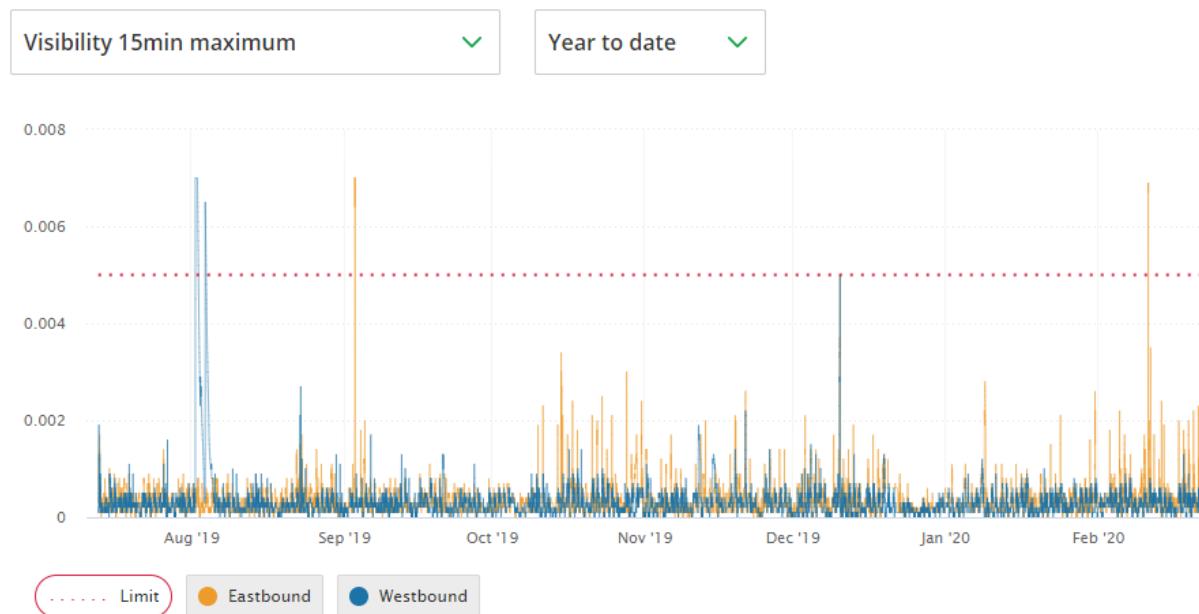
### 2.1.2 Visibility 15 min maximum – Commencement of operations: 13<sup>th</sup> July 2019 to present

- 2nd August 2019: 15-minute maximum reading of 0.007 m-1
- 3rd September 2019: 15-minute maximum reading of 0.007 m-1

Previous investigations of the in-tunnel visibility exceedances attributed the location of the visibility sensors within M4 East and interference of ambient light on the sensors as the cause and major contributing factor causing misreadings.

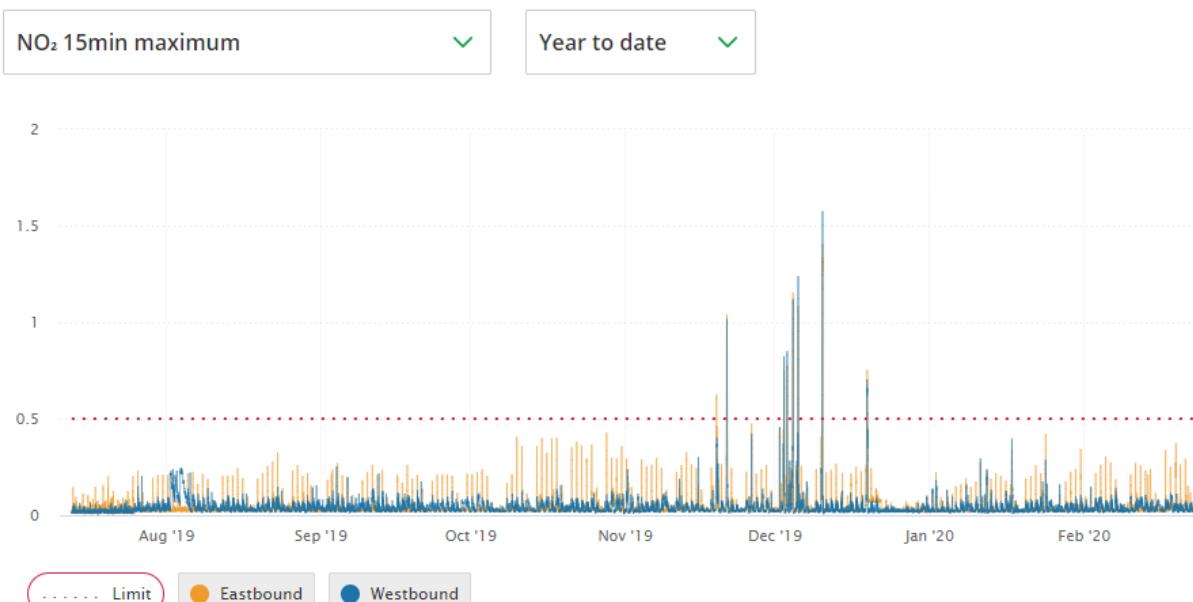
#### 2.1.4. NO<sub>2</sub> 15 min maximum – Commencement of operations: 13<sup>th</sup> July 2019 to present

- 19th November 2019 – Eastbound reading of 0.626 ppm
- 21st November 2019 – Eastbound reading of 1.041 ppm – Westbound reading of 1.017 ppm
- 2nd December 2019 – Eastbound reading of 0.753 ppm – Westbound reading of 0.824 ppm
- 3rd December 2019 – Eastbound reading of 0.775 ppm – Westbound reading of 0.848 ppm
- 4th December 2019 – Eastbound reading of 1.153 ppm – Westbound reading of 1.120 ppm
- 5th December 2019 – Eastbound reading of 1.082 ppm – Westbound reading of 1.236 ppm
- 10th December 2019 – Eastbound reading of 0.751 ppm – Westbound reading of 0.703 ppm
- 19<sup>th</sup> December 2019 – Eastbound reading of 0.751 ppm - Westbound reading of 0.703 ppm

The cause and major contributing factor of the 8 above limit NO<sub>2</sub> recordings were hazardous smoke levels recorded across the Sydney basin during the time of the exceedances. Initial investigations have shown the high ambient smoke levels were interfering with in tunnel NO<sub>2</sub> sensors. Ventilation outlet monitoring of NO<sub>2</sub> remained well below the 2.0 mg/m<sup>3</sup> limit. At the time of in-tunnel above limit reading, both ventilation outlet NO<sub>2</sub> levels recorded readings of below 0.40g/m<sup>3</sup>. As the AQS in tunnel are different to the ventilation outlet, it was thought smoke interference was the primary driver for the high readings.

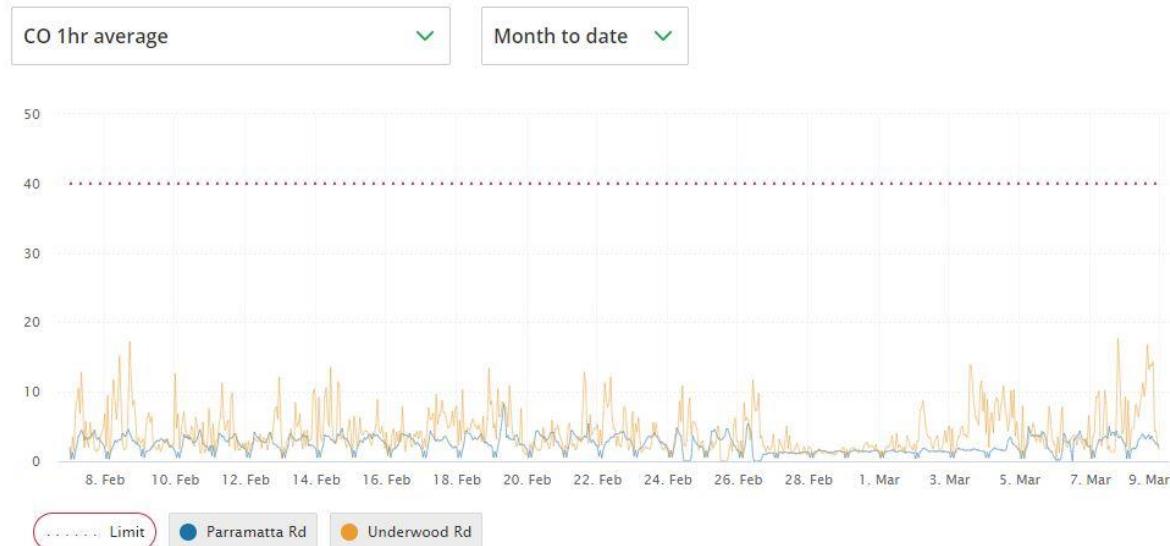
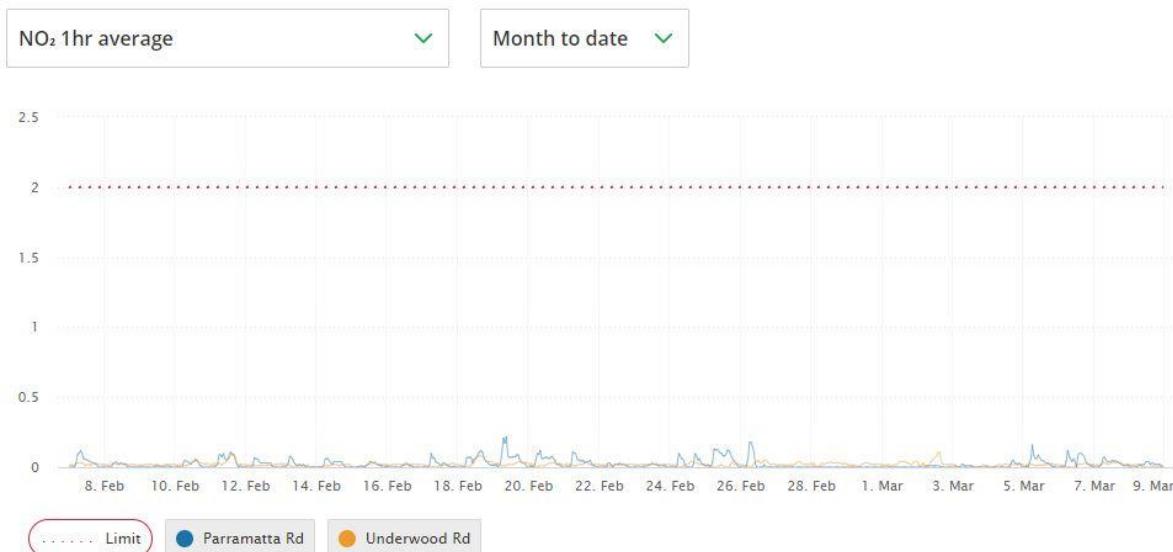
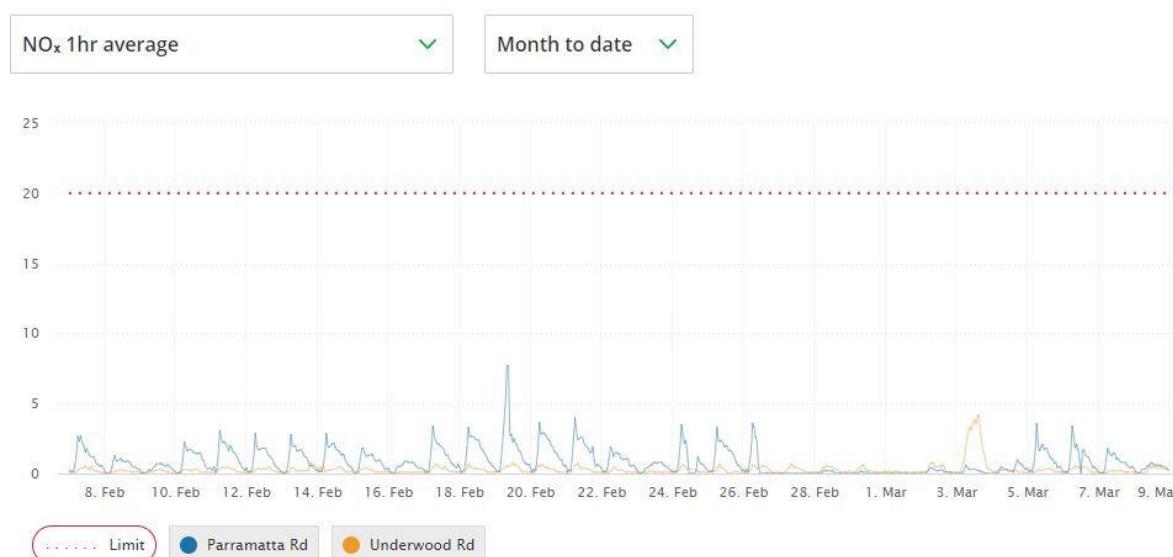
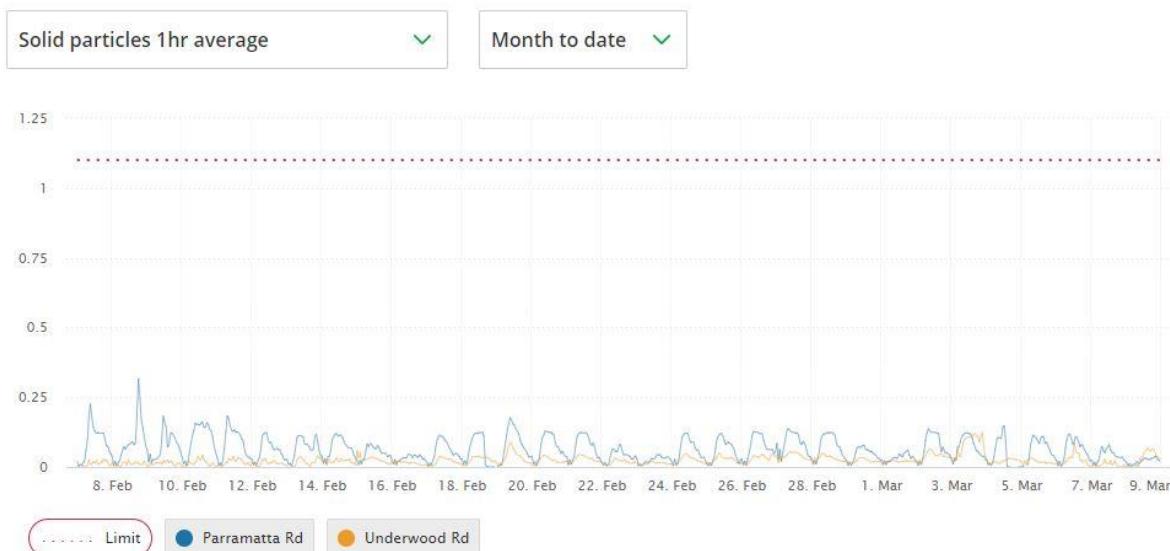
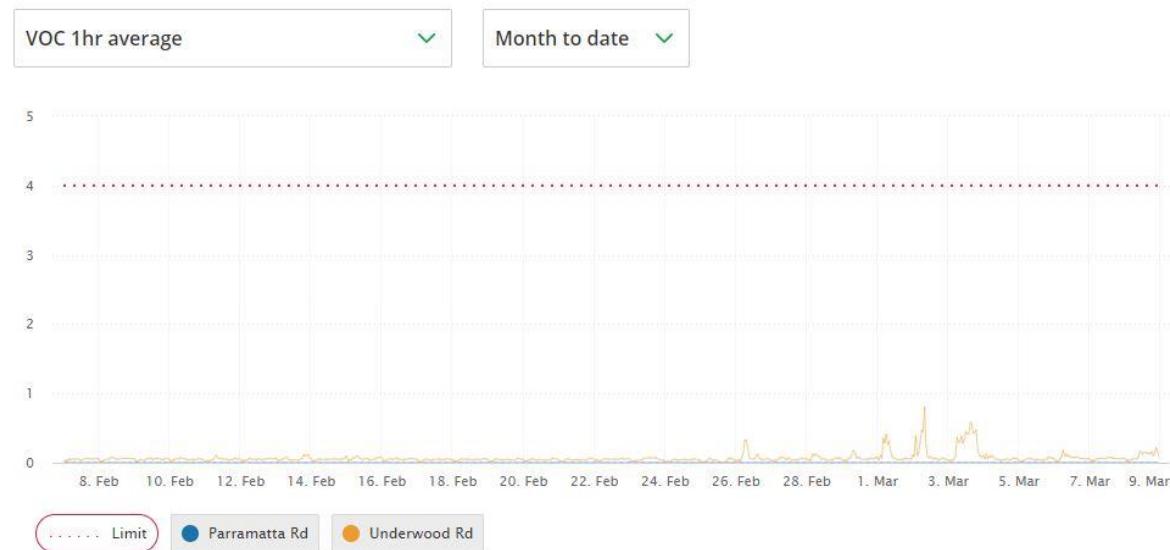
## 2.2 Ventilation Monitoring (Parramatta Road and Underwood Rd Ventilation Facilities)

6. The ventilation outlet data provided in the TAQMSE report shows concentrations for all pollutants, including those within the ventilation outlets, were below specified limits during the periods of the in-tunnel visibility exceedance. Typically, the expectation would be for higher concentrations to be measured within the outlet compared to the average in the tunnel itself due to the build-up of pollution up to the point of release, however, this does not occur. As such, the lower ventilation outlet concentrations to in-tunnel concentrations, supports the likelihood that exceedances were attributed to calibration issues.
